# **AN ECOLOGICAL ASSESSMENT OF STREAMS IN GAITHERSBURG, MARYLAND: 2001-2002**

**November 2002**

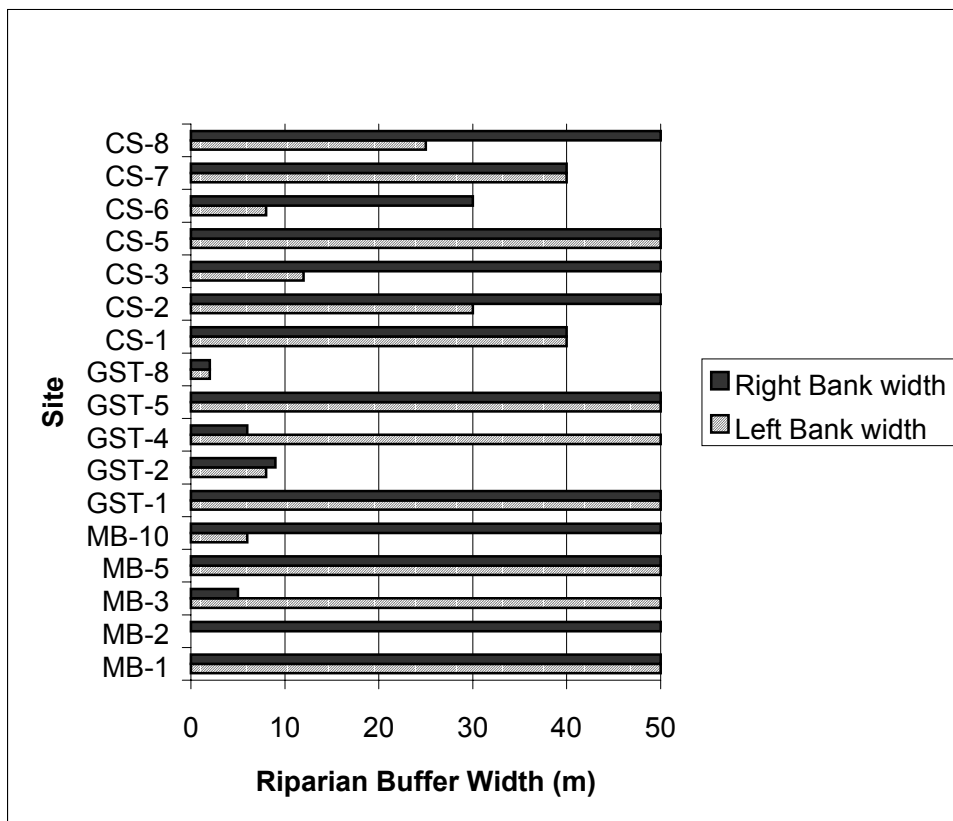
This stream assessment described the extent of riparian vegetation at each sampled site, estimated as the functional width of the riparian. In the field, buffer width is estimated for up to 50 m on each side of the stream. Results (Figure 2-9) show that many sampled sites had fairly extensive buffers. Twelve of 17 sites had a 50 m buffer on at least one side, and six sites had 50 m of vegetation on both sides of the stream. A few sites (e.g., GST 8) had very little vegetation.

Figure 2-9. Riparian buffer width (to 50 meters) for City of Gaithersburg 2001-2002 sampling sites

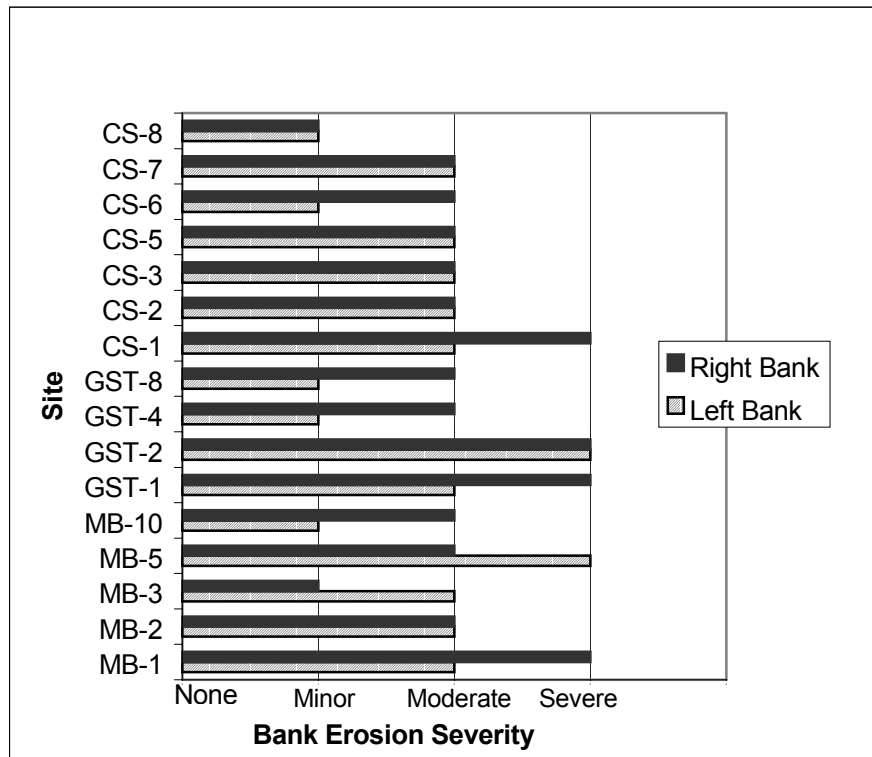
Bank erosion is a substantial and widespread problem in Gaithersburg streams. Figure 2-10 summarizes field ratings of the degree of bank erosion observed, based on the MBSS sampling method. All sites exhibited some degree of bank erosion, whether minimal, moderate, or severe. Moderate to severe bank erosion was observed at 15 of 16 sites. Bank erosion was rated as severe at five sites (along at least one side of stream), and severe erosion was noted along both banks at GST-2.

Bank pins were installed and monitored during each sampling period to aid in quantifying bank erosion rates. Only a few changes were recorded over the seven-month interval between bank pin installation (December 2001) and final sampling (June 2002). All changes were at Great Seneca Tributary sites. Site GST 2 lost 4 cm of bank between spring and summer. Site CS 5 lost 2cm by between fall and spring, and an additional 2 cm by summer. At site GST 8, the bank slumped between spring and summer (showing an apparent gain of 8 cm at the bank pin location). Because bank pin assessments are a good long-term assessment tool, all bank pins

Figure 2-10. Bank erosion observed at City of Gaithersburg 2001-2002 sampling sites

were left in place at the conclusion of summer field sampling. We recommend periodic monitoring of these pins in future years to further evaluate bank erosion.

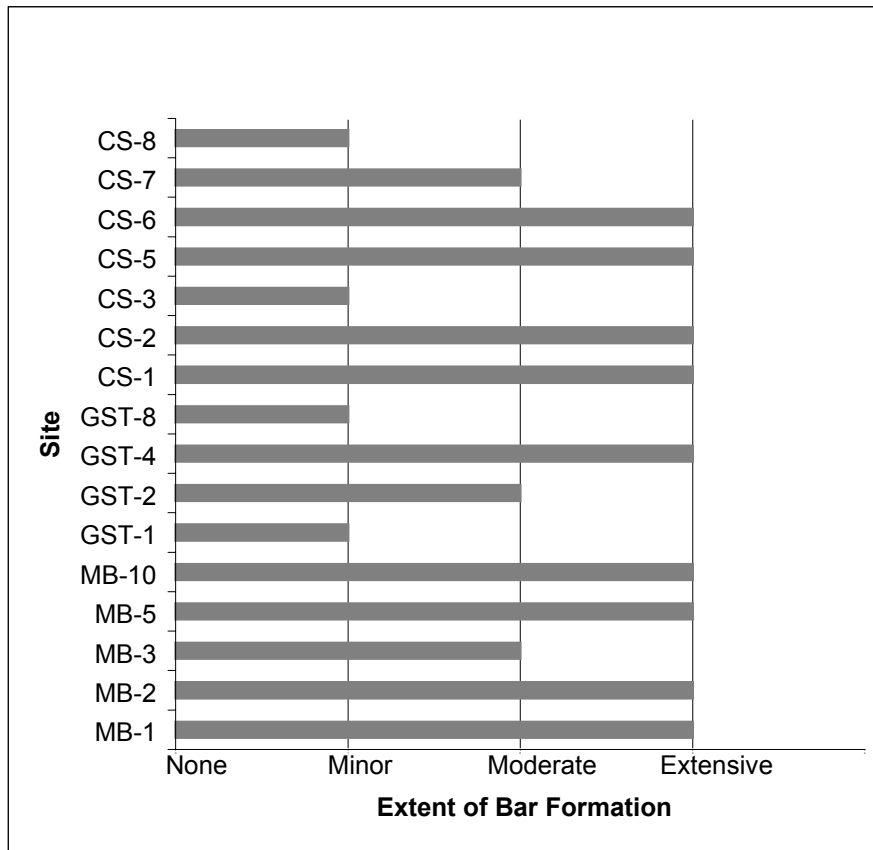
Formation of side or mid-channel bars is another sign of channel instability. Unstable channels, in which gravel and sand substrate shift readily with high flows, are common in much of the stream network in Gaithersburg. Channels that are already entrenched because of prior downcutting and incision are particularly vulnerable to further instabilities of channel and bank materials because they no longer support a natural hydrologic and sediment transport regime.

All sites showed some extent of bar formation (Figure 2-11). Assessments, using MBSS protocols, rate bar formation as minor, moderate, and extensive. Bar formation was moderate to extensive at 12 of 16 sites. Gravel and sand were the predominant bar materials noted.

Figure 2-11. Extent of bar formation at City of Gaithersburg 2001-2002 sampling sites

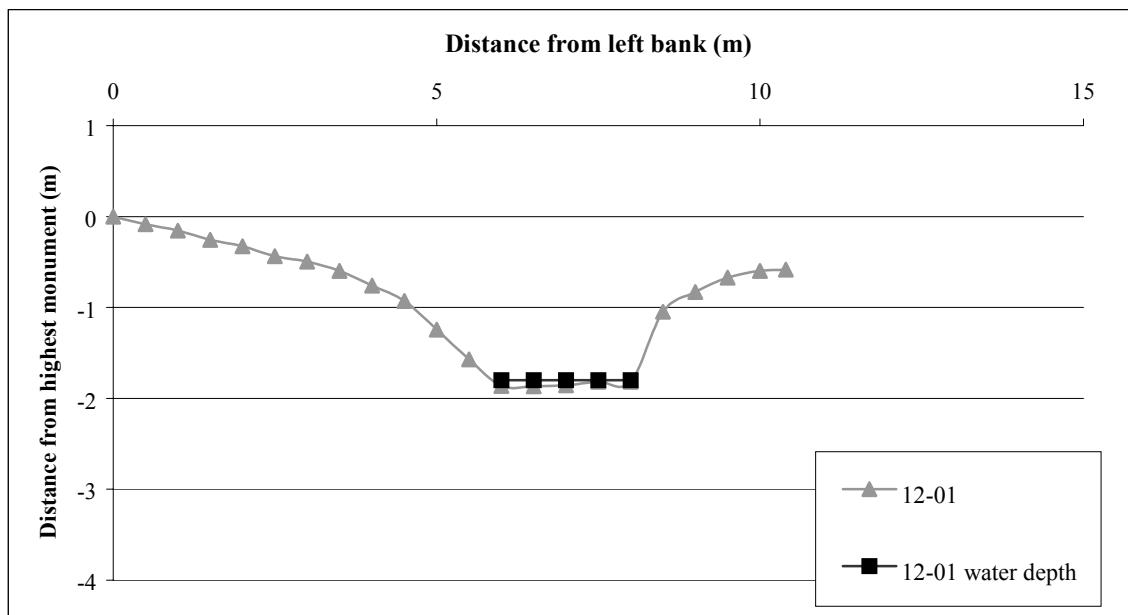
Two examples of cross-sectional data from GST 8 and CS 5 are shown in Figures 2-12 and 2-13. GST 8 represents a more natural channel condition, with a wetted channel that fills the stream channel from bank to bank. This site has gradually sloping banks, indicating minimal sediment deposition, bank erosion, and relatively stable flows. In contrast, the cross section for CS 5 shows that the stream channel is overwidened and has high, steep banks. A relatively small amount of flow is present within a much larger channel, with a substantial sediment bar filling much of the channel width. This is likely a result of flashy flows, severe bank erosion, high sediment loads, and excessive sediment deposition. A complete set of graphs for cross-sections

Figure 2-12. Cross-sectional profile of station GST 8, City of Gaithersburg 2001-2002 sampling

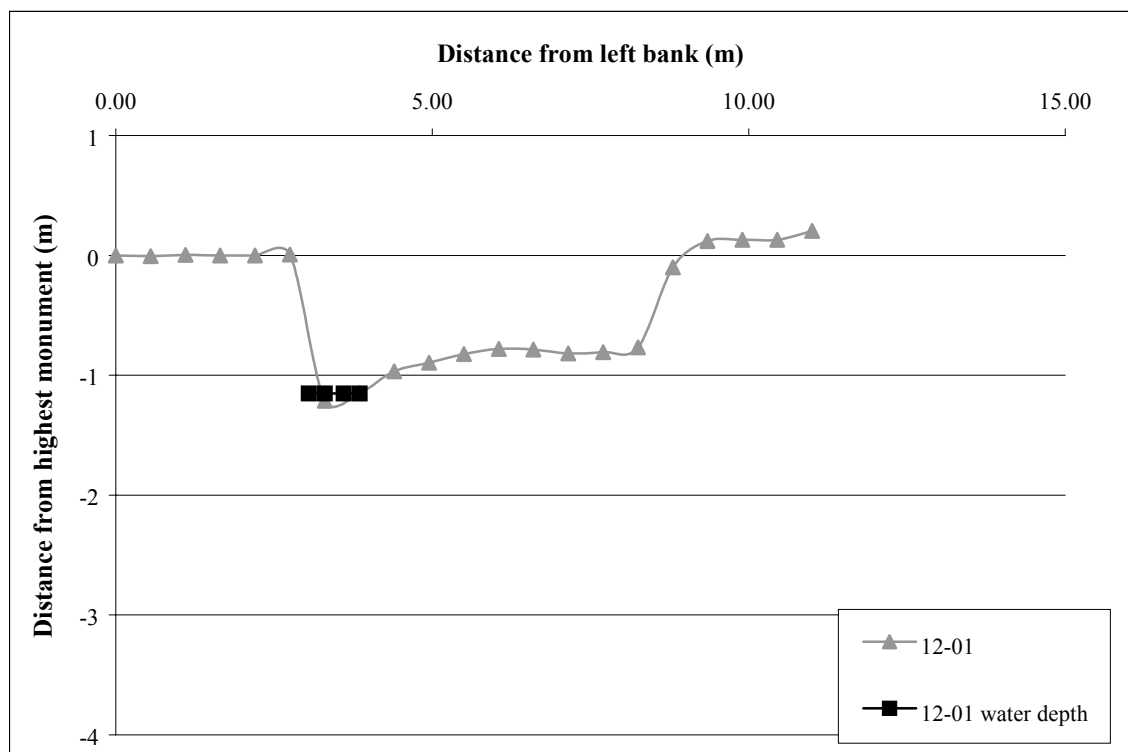
Figure 2-13. Cross-sectional profile of station CS 5, City of Gaithersburg 2001-2002 sampling

at each site are included in Appendix B. In general, cross-sections of the Gaithersburg stream sites confirmed other observations that channels are highly impacted, with a high degree of channel incision, mild to severe bank erosion, and extensive bar formation.

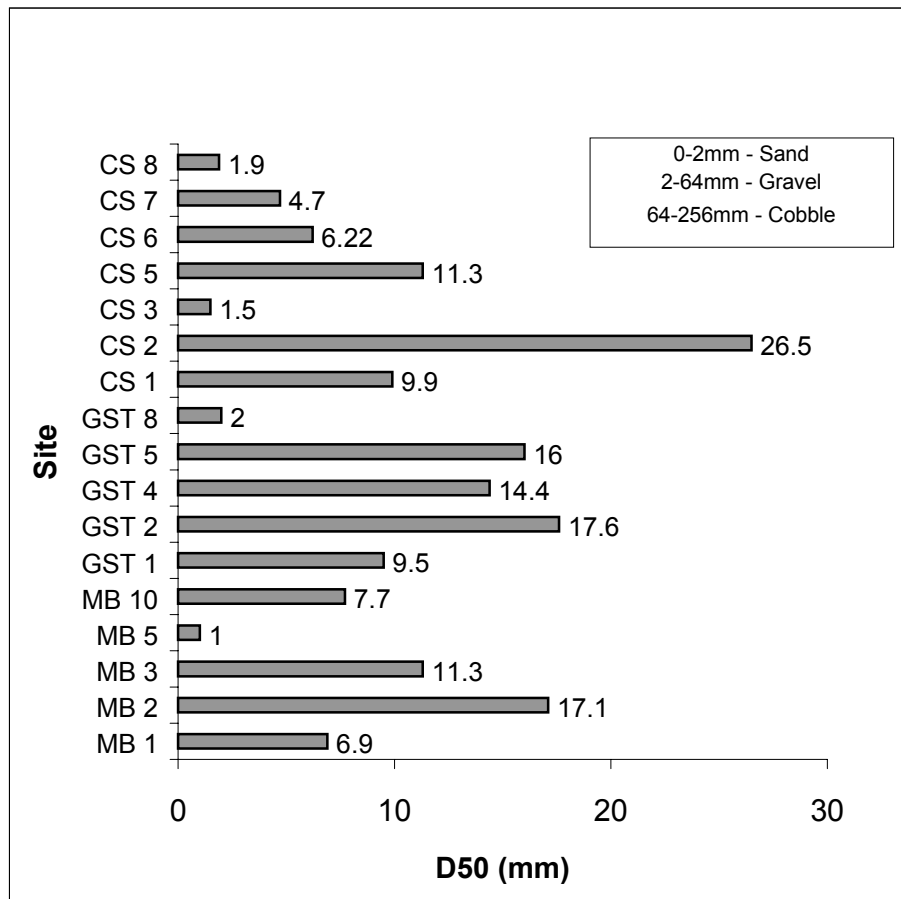
stream was relatively large, such as small and large cobble, while a small D50 indicates smaller substrate is present, such as sand and silt. D50 values from the 16 Gaithersburg sites are shown in Figure 2-14, which indicates that most streambeds are made up of medium sized gravel, except for MB 5, GST 8, CS 3, and CS 8, which were predominantly sand bottoms.

Figure 2-14. Median substrate particle size (D50) for City of Gaithersburg 2001-2002 sampling sites

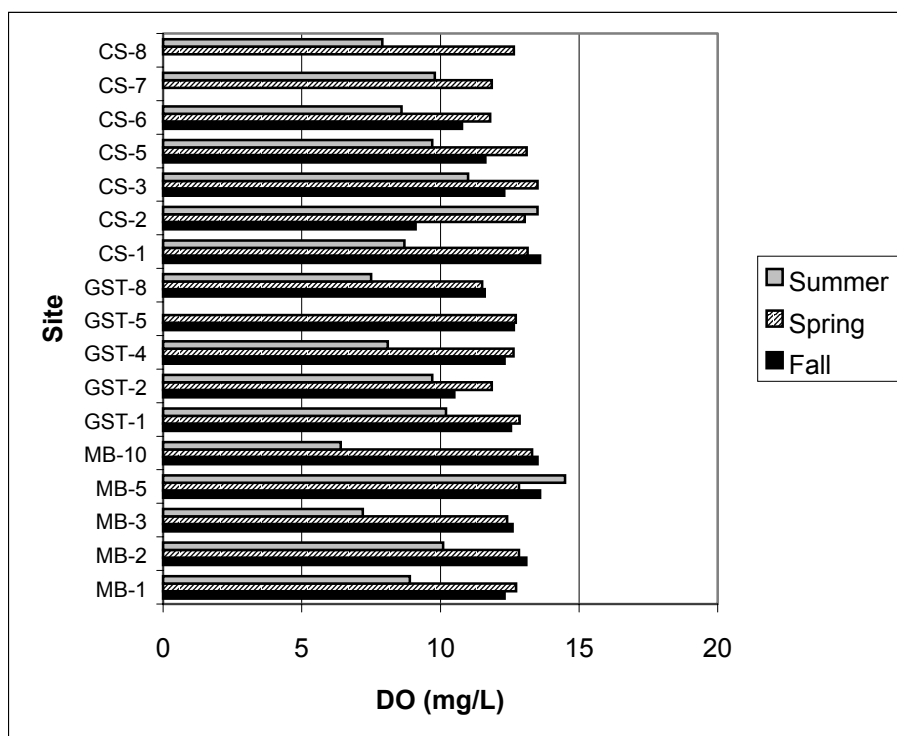
Figure 2-16. Dissolved Oxygen (mg/L) at City of Gaithersburg 2001-2002 sampling sites

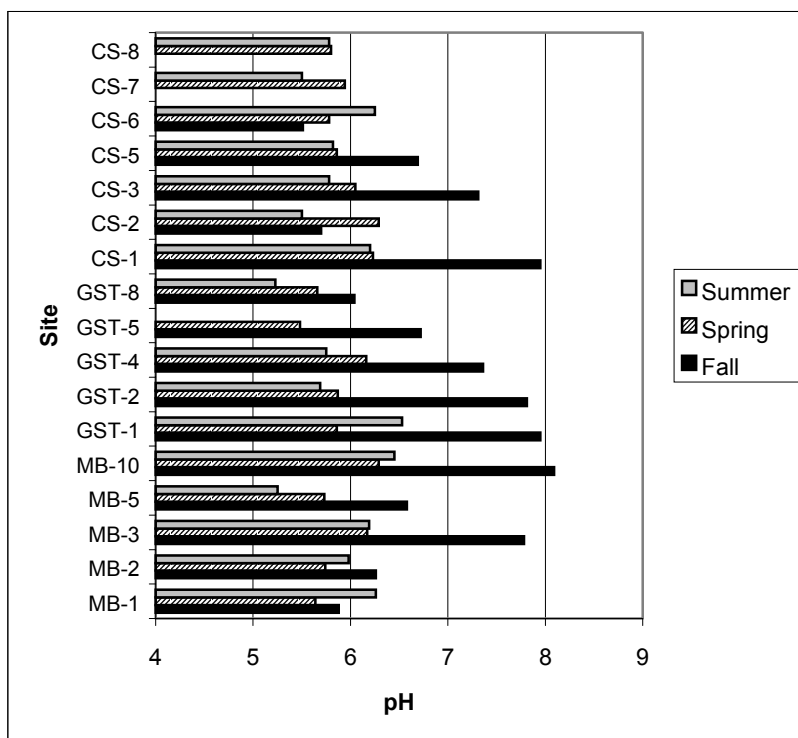
Figure 2-17. pH (standard units) at City of Gaithersburg 2001-2002 sampling sites

Summer pH levels remained similar to those recorded in the spring, with 10 sites having a pH less than 6.0. To assess whether pH values for Gaithersburg streams differed from those elsewhere in the region, data were compared with MBSS sites sampled throughout Montgomery County. In comparison, summer pH values in Gaithersburg tended to be lower than elsewhere in the County (Figure 2-20).

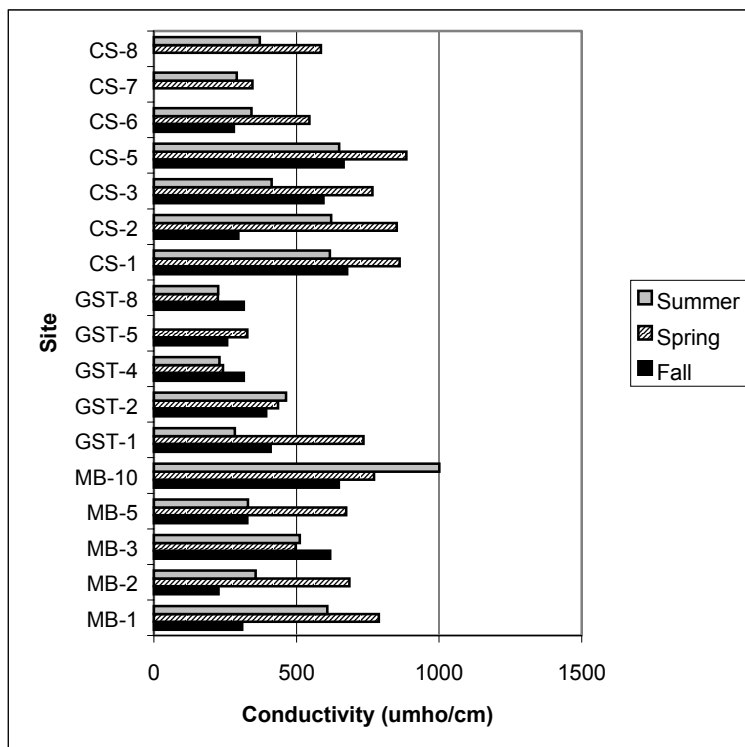
Figure 2-18. Conductivity (µmho/cm) at City of Gaithersburg 2001-2002 sampling sites

In addition, conductivity was somewhat high at several sites, including MB 3, MB 10, CS 1, and CS 5. While conductivity may be related to dissolved minerals stemming from underlying geology, in some cases, unusually high or variable conductivity can indicate pollution.

Summer water quality is presented in Table 2-18. In general, conductivity measurements were lower than those observed in the spring, with the exception of MB 10, where conductivity was alarmingly high (1001 Fmho/cm). Water temperatures in the summer were warm, which is to be expected since it was an extremely hot period in late June 2002. DO values were lower in the summer, as expected, since DO levels tend to fall with rising water temperatures. However, all sites remained above 5 mg/L DO, the COMAR standard and the level generally considered healthy for aquatic life.

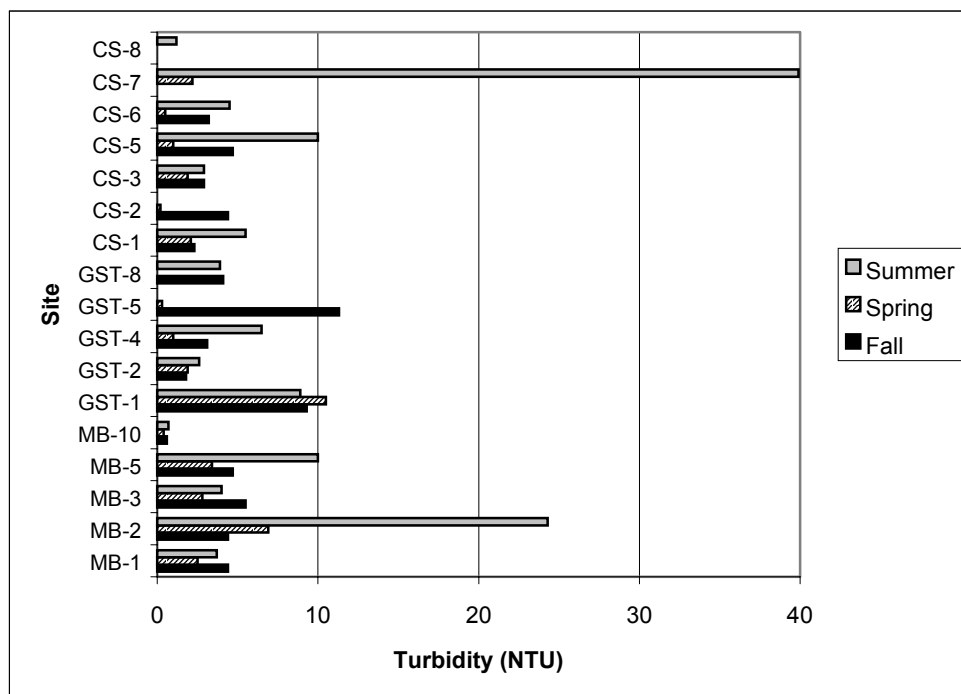
Figure 2-19. Turbidity (NTUs) at City of Gaithersburg 2001-2002 sampling sites

Turbidity was normal at most sites, but there were two sites that exhibited somewhat higher measurements. MB 2 (turbidity of 24.3 NTU) was sampled just as a slight rainstorm was beginning to break. Rainwater carries fine particles into the stream, which raises turbidity levels. CS 7 also had high turbidity (39.9 NTU), but was sampled during dry conditions. CS 7 is located just below a confluence of two smaller tributaries; one is the outfall of pond by the GE complex, and the other runs by the new Lakelands development. The water from the pond outfall was clear, while the water from the active development area was quite turbid. This was believed to be the source of the high turbidity level observed at this site.

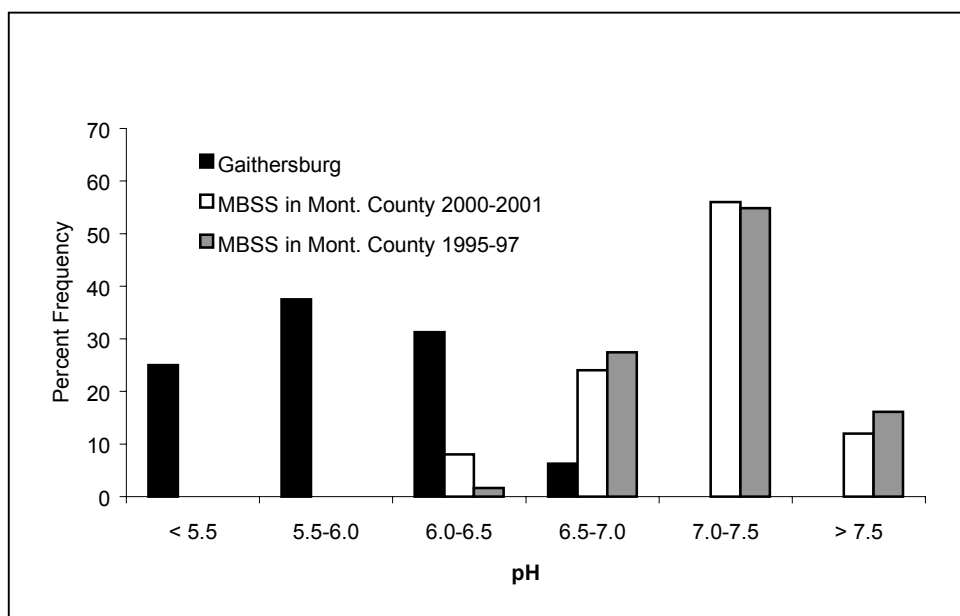
Figure 2-20. Comparison of Gaithersburg Summer pH Results with MBSS Sites in Montgomery County

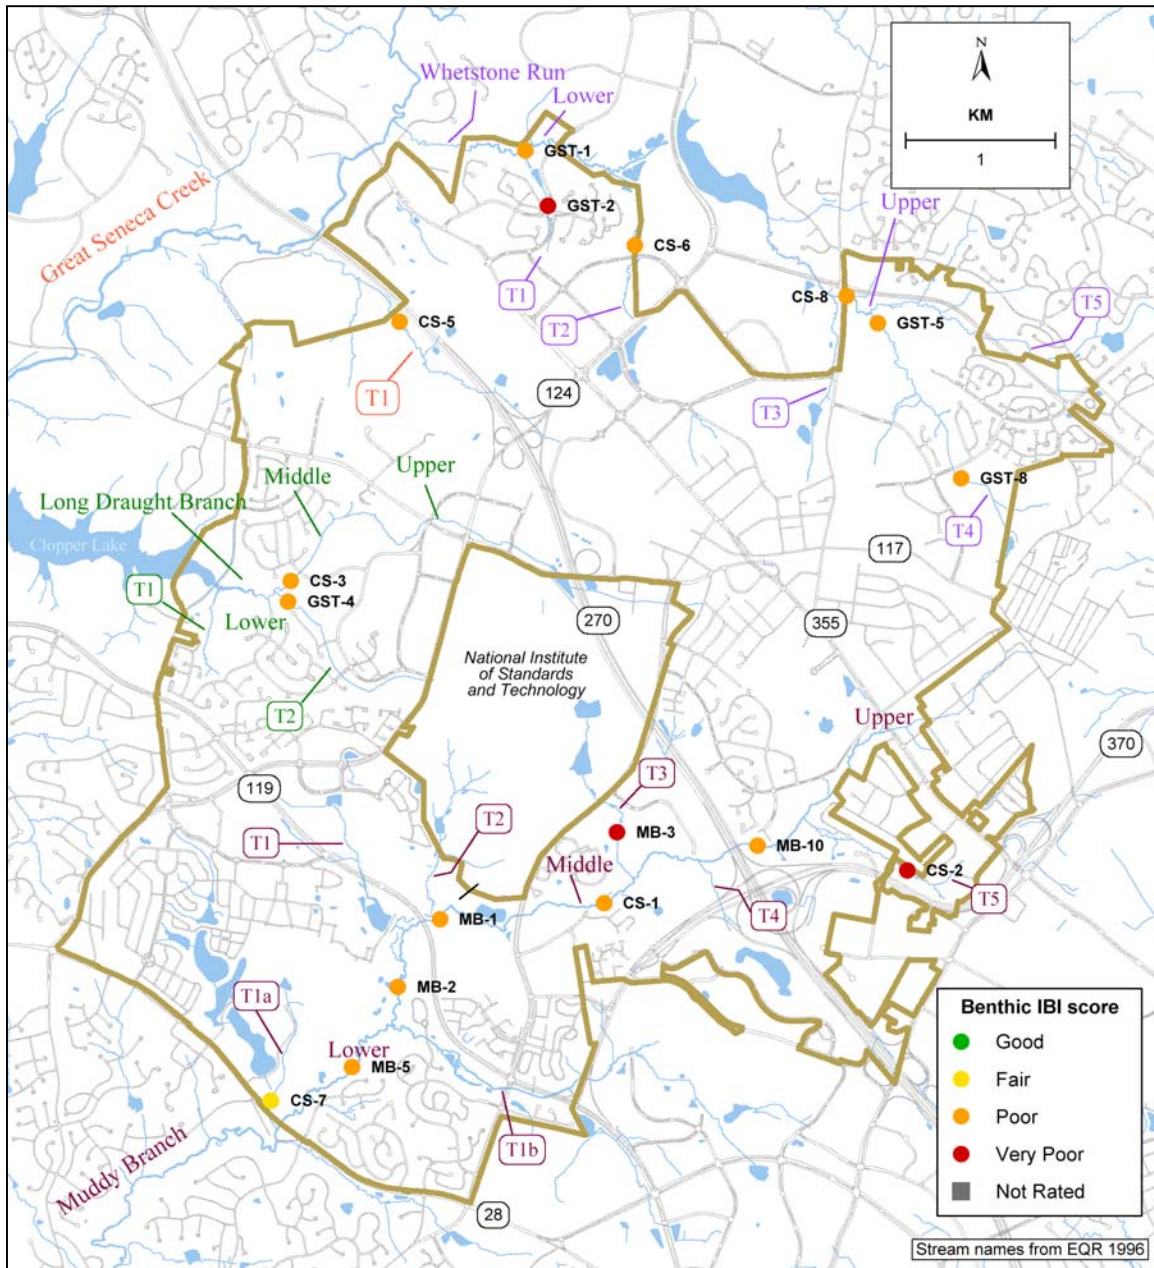
Final benthic IBI scores ranged from 1.44 (Very Poor) to 3.44 (Fair). The geographic distribution of these scores is shown in Figure 2-21. The mean benthic IBI score at the 10 randomly selected sites was 2.38, indicating the Gaithersburg streams were generally in Poor condition. In comparison with MBSS Round One data, this value was slightly lower than the statewide mean benthic IBI of 2.79 (Poor) and the mean benthic IBI for sites within Montgomery County of 2.83 (Poor).

Figure 2-21. Benthic IBI scores for sites sampled in the City of Gaithersburg, 2001-2002

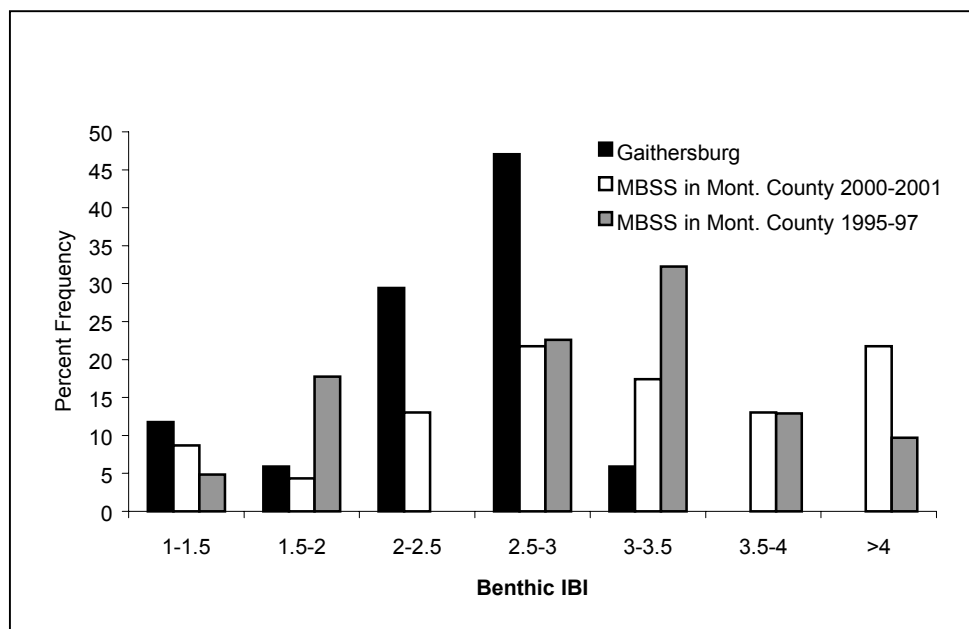
Interestingly, although a number of MBSS sites in the County scored in the Good to Fair range, indicating conditions comparable to reference, only one Gaithersburg site fell into this range (Figure 2-22). However, Gaithersburg streams were roughly comparable with the Montgomery County urban sites from the MBSS data set (Figure 2-23).

Figure 2-22. Comparison of Gaithersburg 2001-2002 Benthic IBI Results with MBSS Sites in Montgomery County

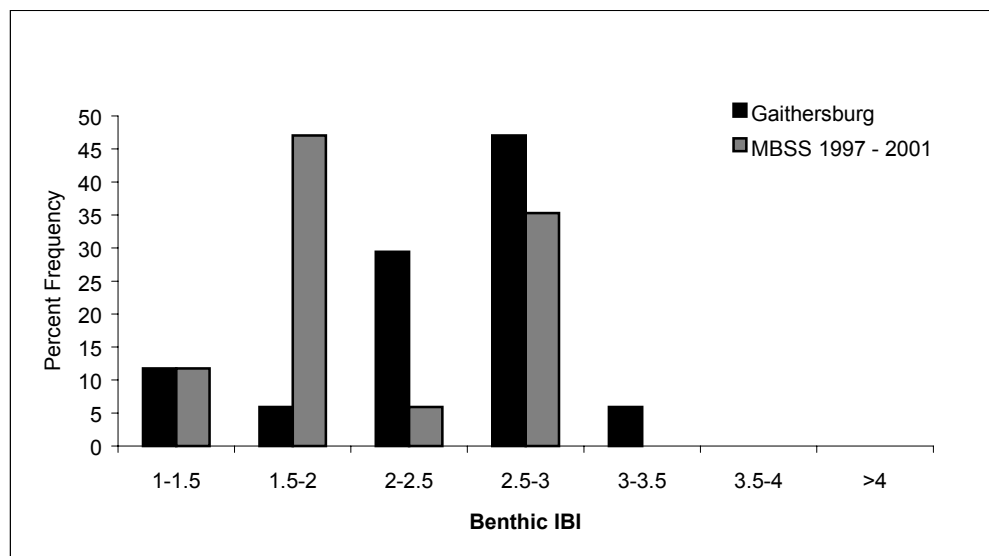
Figure 2-23. Comparison of Gaithersburg 2001-2002 Benthic IBI results with MBSS sites in Montgomery County, MBSS urban sites only

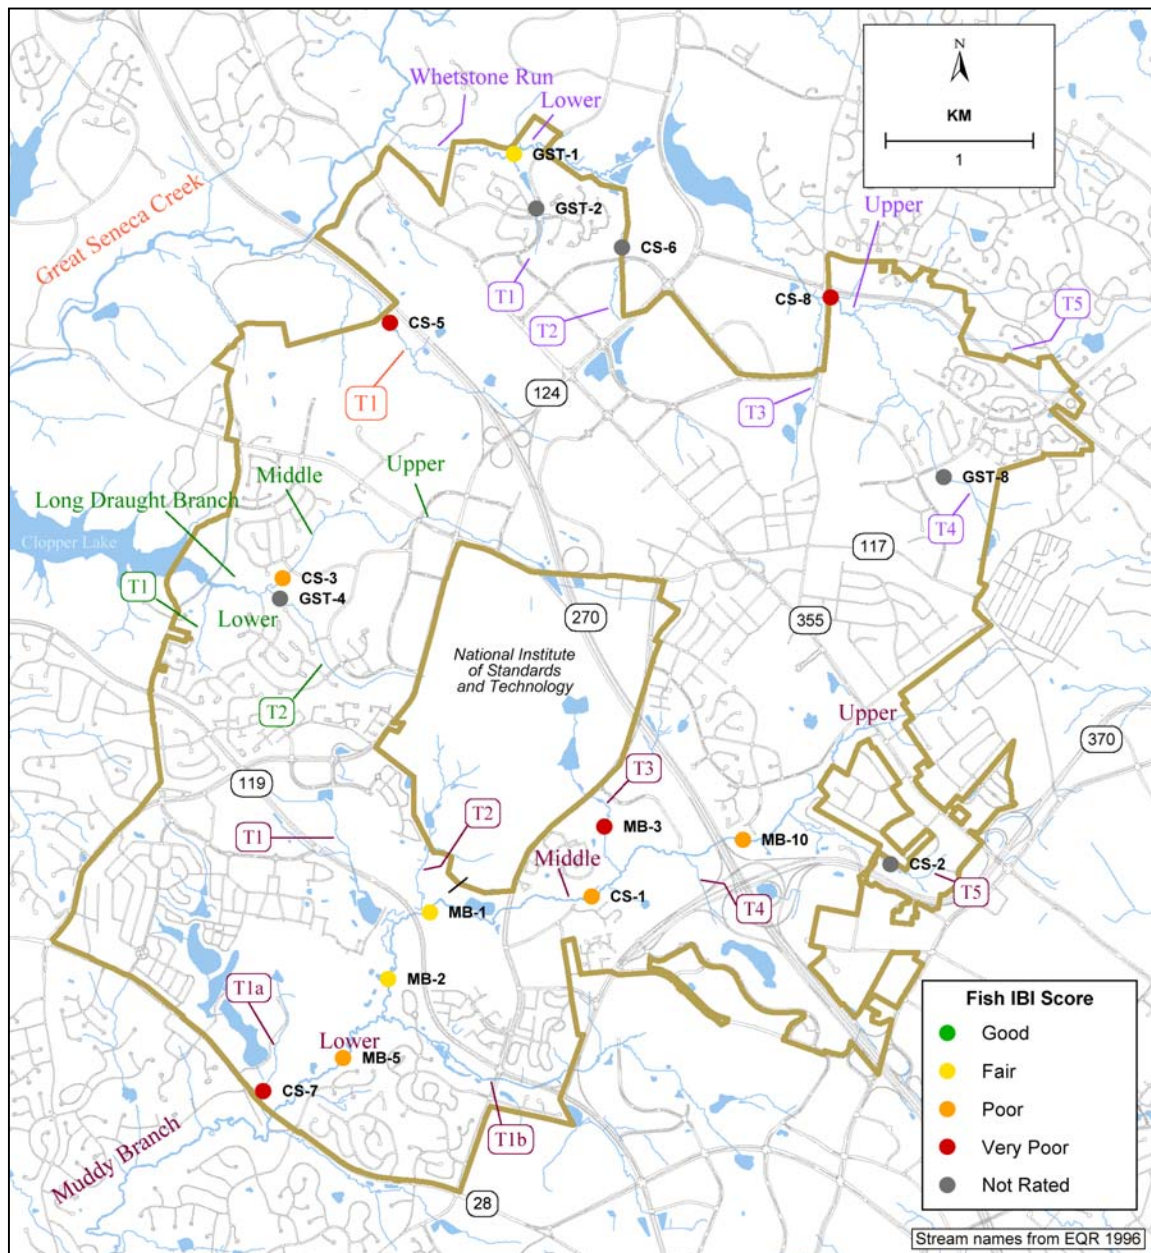
Table 2-22 shows the fish bioassessment results for each site, including fish IBI, number of species and individuals found, percent tolerant species, and total biomass. The geographic distribution of Fish IBI scores is shown in Figure 2-24. At all sites sampled, the fish

assemblages were dominated by species that can tolerate degraded water quality and habitat. At several sites (GST 2, GST 4, CS 2, CS 6, and CS 7), fish abundance and species richness were quite low. Most of these sites were smaller tributary streams, where the expected number of fish would be low. In fact, the MBSS fish IBI is not used for very small streams (those with catchment area less than 300 acres), because even under reference conditions, few fish would be found. The highest fish IBI scores were found at sites MB 2 and GST 1, which received Fair scores (3.67 and 3.22 respectively). These sites had 15 and 14 species of fish present, respectively, which are good numbers for relatively small streams. The lowest scores were at sites CS 7 in the Muddy Branch watershed (1.67), and at CS 5 and CS 8 in the Great Seneca Tributary watershed (1.89 at both).

Figure 2-24. Fish IBI scores for the sites sampled in the City of Gaithersburg, 2001-2002. Sites with upstream catchments < 300 acres were not rated by the fish IBI.

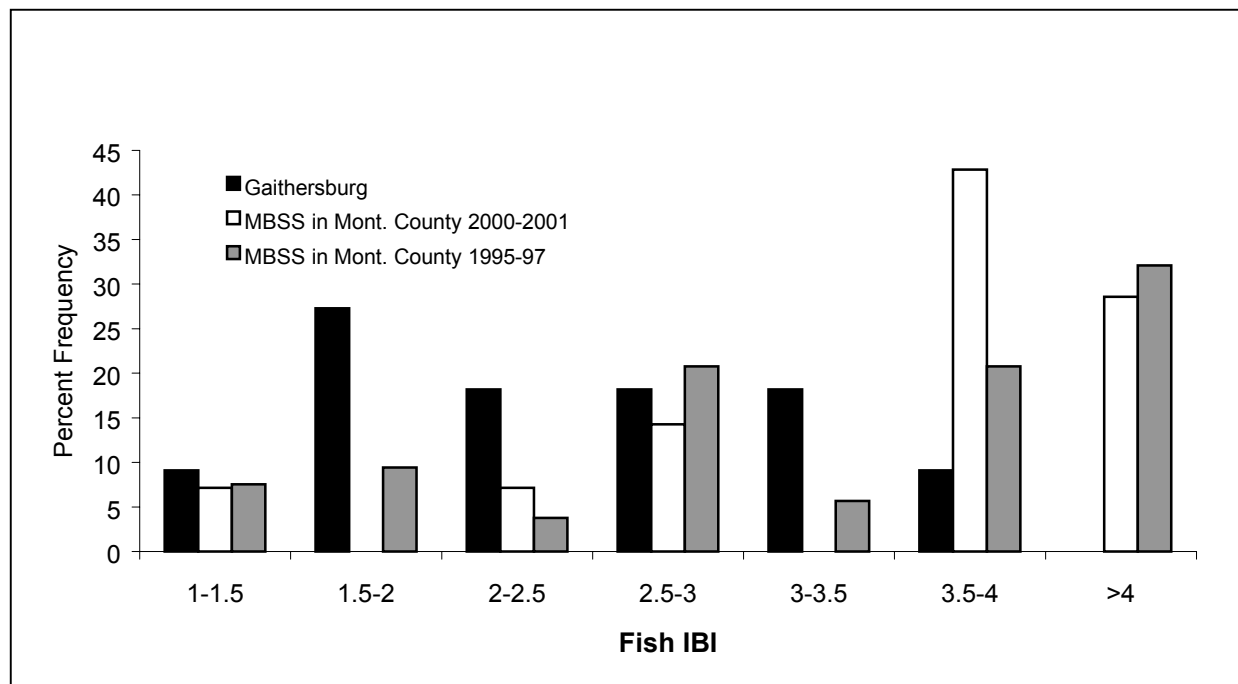
Gaithersburg fish IBI results were compared to those from other streams in Montgomery County sampled by MBSS (Figure 2-25). The distribution of scores for Gaithersburg does not include any sites in the Good range (fish IBI > 4), while some sites elsewhere in the County did score in this range. When Gaithersburg sites are compared only with the urban sites in Montgomery County (Figure 2-26), scores were more similar.

Figure 2-25. Comparison of Gaithersburg 2001-2002 fish IBI results with MBSS sites in Montgomery County

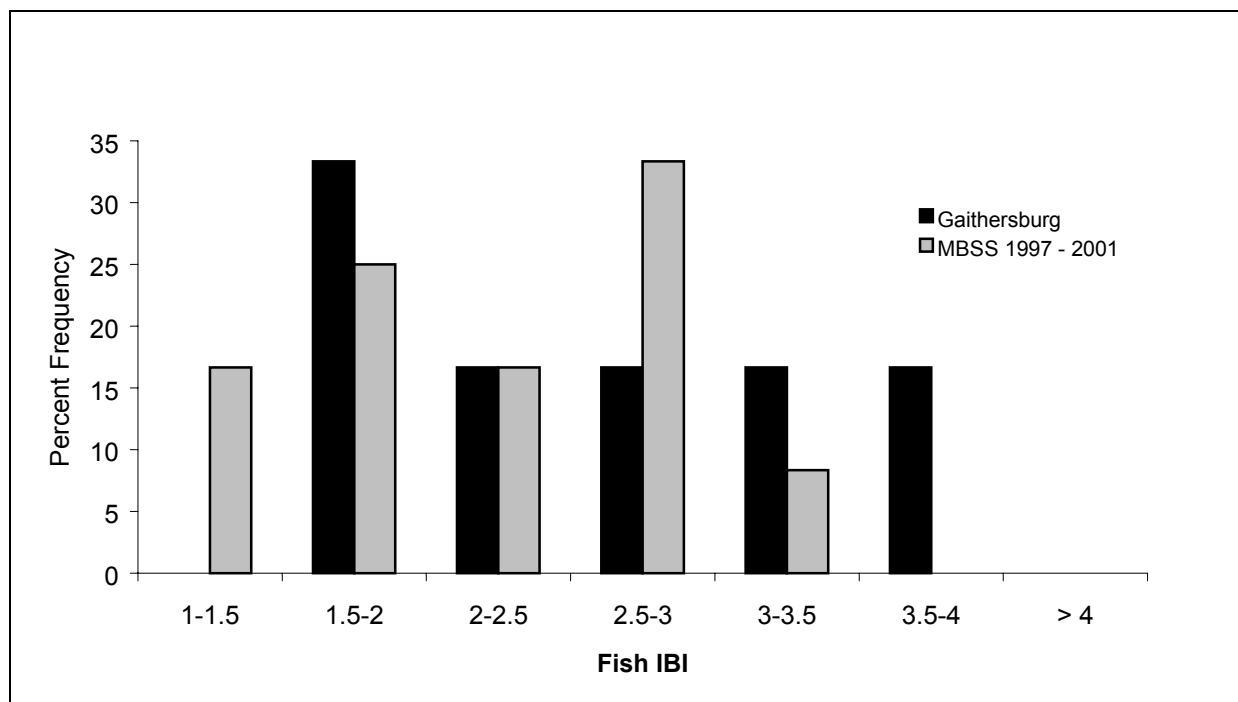
Figure 2-26. Comparison of Gaithersburg 2001-2002 fish IBI results with MBSS sites in Montgomery County, MBSS urban sites only

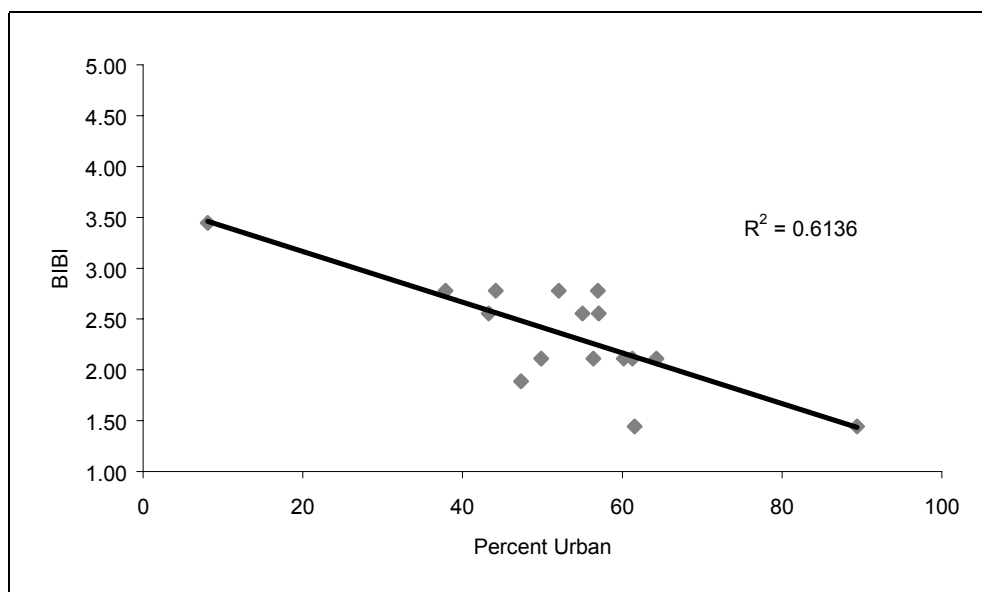
In order to better understand the relationship between the biology and the land use at each of these sites, the correlations between the benthic and fish IBIs and urban land use was examined. The benthic IBI showed a strong relationship to urban land use (Figure 2-27;  $r^2 = 0.61$ ), decreasing in value as the percentage of urban land in the catchment upstream of the sample location increased. The fish IBI did not show a strong relationship with urban land use ( $r^2 = 0.06$ ) perhaps because some of the sites with the highest percentages of urban land drained catchments too small to be rated with the MBSS fish IBI.

Figure 2-27. Relationship between Gaithersburg 2001-2002 Benthic IBI results and urban land use

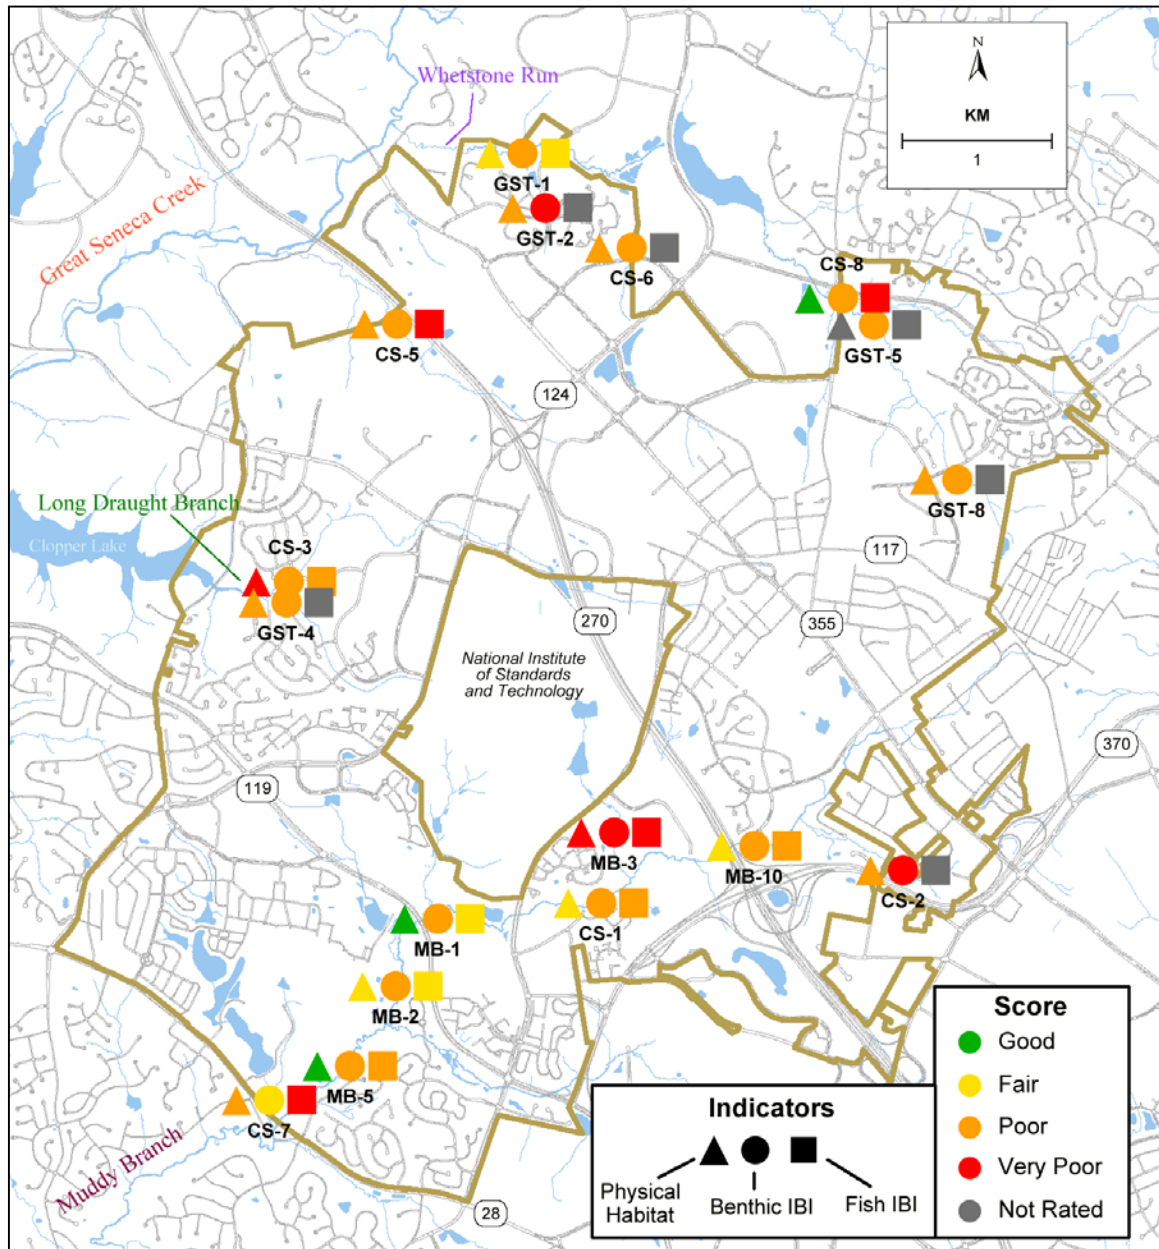
The City of Gaithersburg contains over 24 miles of streams within a highly urbanized area. Some of the features documented by this stream assessment included continuous, if low, perennial stream flows during extended dry summer conditions (although sites were not observed during the extreme low flow of July-August 2002), fair fish diversity and biomass at several sites throughout the city, and reasonable dissolved concentrations of oxygen and water temperature. Several characteristics common to disturbed stream channels were evident within many stream sites. These disturbed stream characteristics included low pH, high conductivity, high turbidity, moderate to severe bank erosion, a degree of high channel incision, extensive channel bar formation, and high percentages of tolerant biota. Indicators for physical habitat, benthic macroinvertebrates, and fish scored predominantly in the Poor range, as shown in a map integrating all indicator results (Figure 2-28).

Figure 2-28. Integrated assessment of stream condition, as rated by physical habitat, benthic, and fish indicators, for sites sampled in the City of Gaithersburg, 2001-2002.
